87500 Door Handle service bulletin

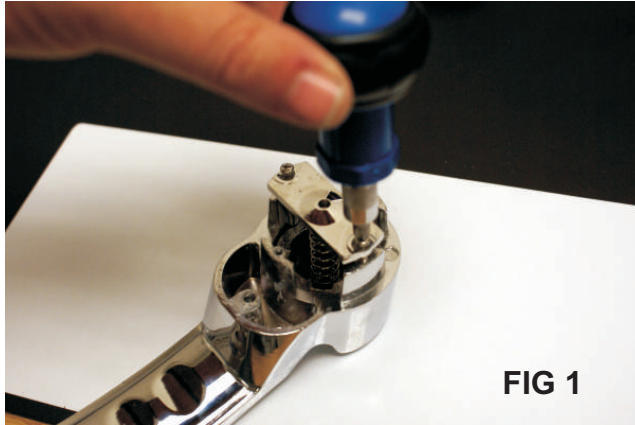
We have identified a potential issue with the JK door handles that is easily remedied but is not at first obvious. If the button shaft is not tightened properly it can interfere with the lock mechanism. If not tight it can also unscrew and fall out making the door handle not operate.

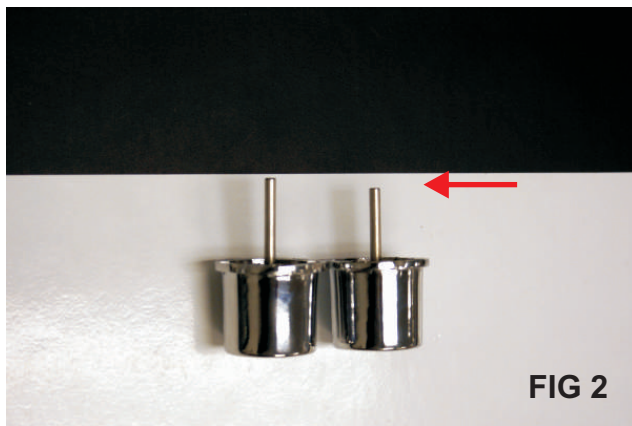
Remove the keeper bracket with a Phillips screw driver. (FIG 1) Note the difference in the length of the two shafts (FIG 2). The part on the left is not screwed into the button far enough and could keep the lock mechanism from operating properly. You can see in the picture below (FIG 3) that the shaft is threaded on the end. In some cases it may not be installed into the button properly.

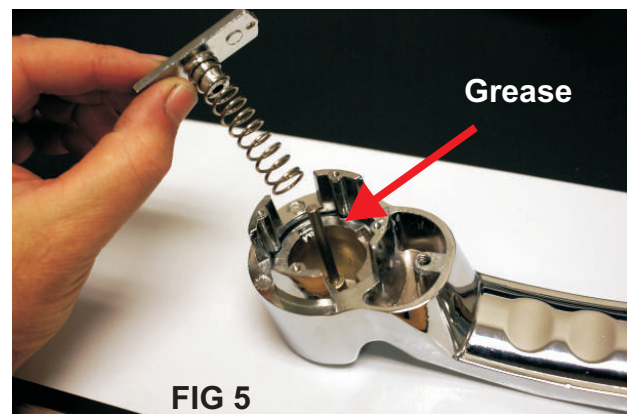
It is a good idea to grease the shaft in the area shown below before re-assembly.
